**Flood Control Project Maintenance
Levee Inspections**

Fall 2015 Levee Maintenance Deficiency Summary Report

Sacramento River Basin

Sutter Maintenance Yard East Levee Sacramento River

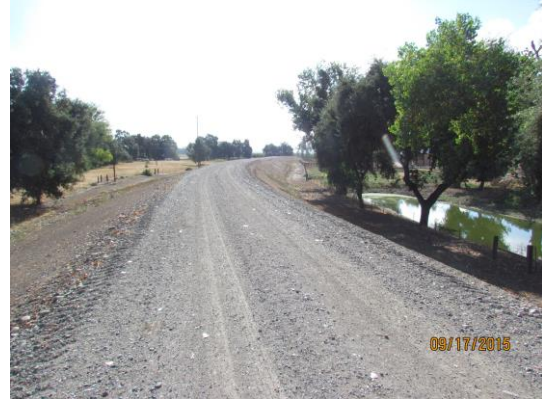
Photo 1 of 1 : FA_2015_ST0003_267_1_20151013_00002.jpg

LM Start	0.08	Rating **	A	Issue No.	1
LM End	0.08	Issue Type +	Ma	Location *	LS
Category	Earthen Levee			GPS Latitude/Longitude	
				Start	End
Item	Vegetation			39.337897 °	39.337897 °
				-122.020677 °	-122.020677 °
DWR ID	DWR_ST0003_04_f_2015_1				
Action/Comments					
Control annual grass and weeds on the levee slopes and easements. Inspector Comments: Sutter Yard Burned and dragged both slopes.

View of the levee slope with no vegetation.

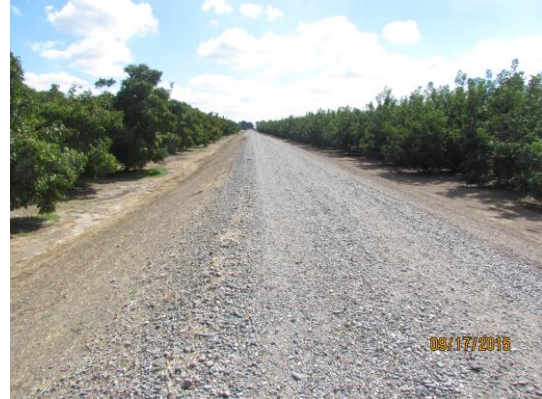
Photo 1 of 1 : FA_2015_ST0003_268_1_20151013_00001.jpg

LM Start	0.36	Rating **	A	Issue No.	1
LM End	0.36	Issue Type +	Ma	Location *	LS
Category	Earthen Levee			GPS Latitude/Longitude	
				Start	End
Item	Vegetation			39.343158 °	39.343158 °
				-122.016377 °	-122.016377 °
DWR ID	DWR_ST0003_05_f_2015_1				
Action/Comments					
Control annual grass and weeds on the levee slopes and easements. Inspector Comments: Sutter Yard Burned and dragged both slopes.

View of the levee slopes with no vegetation.
